Docket No. 217 – Development and Management Plan Inspection

Northeast Utilities Service Company Certificate of Environmental Compatibility and Public Need for the construction of a 345-kV electric transmission line and reconstruction of an existing 115-kV electric transmission line between Connecticut Light and Power Company's Plumtree Substation in Bethel, through the towns of Redding, Weston, and Wilton, and to the Norwalk Substation in Norwalk, Connecticut.

Date: July 15, 2004

Location: Norwalk Substation Expansion

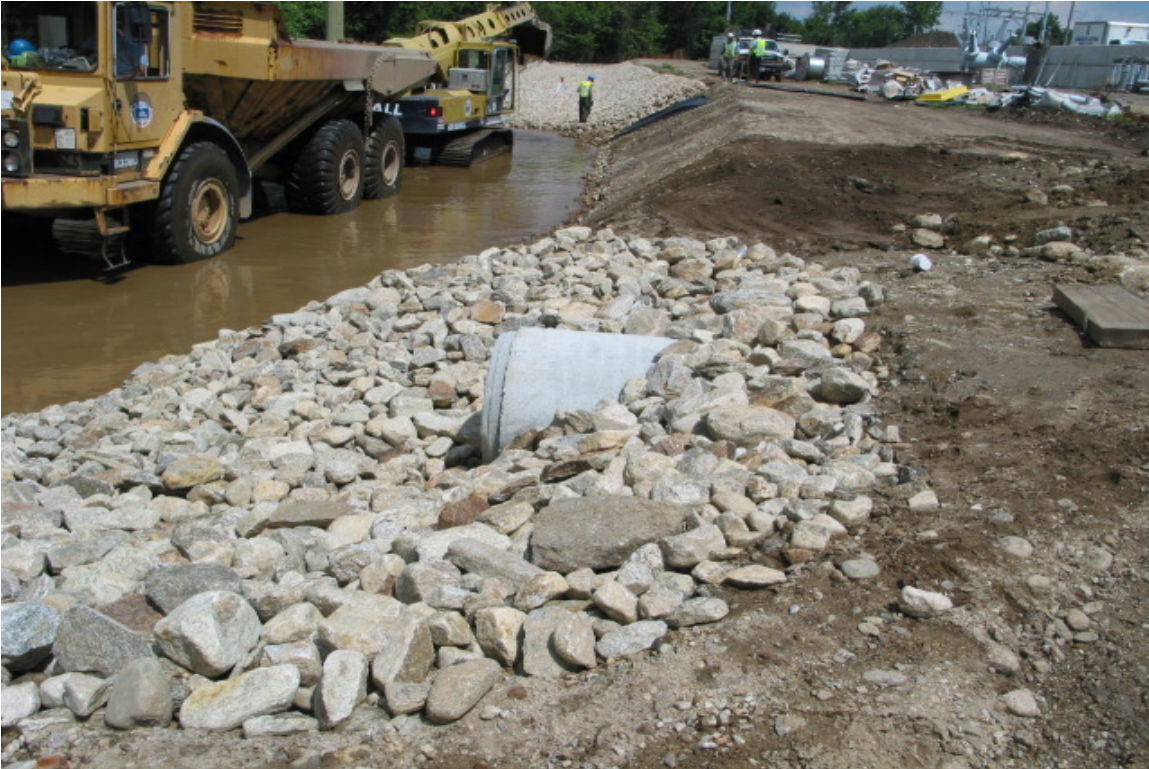
View of the catch basin w/separator outlet to the overflow channel. The inlet is not yet at grade but will be operational when this occurs. 7/15/04

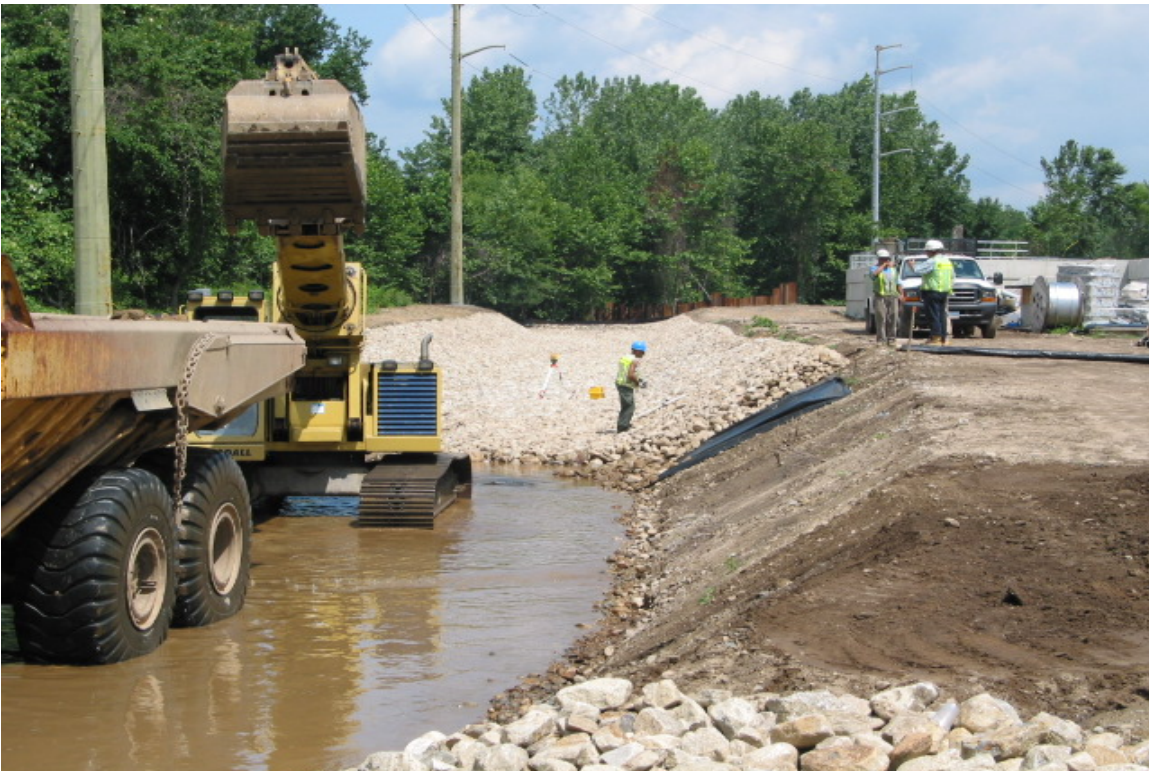
View of installation of liner and cobblestone in the overflow channel. The work is reaching completion towards the southern end of the channel. 7/15/04

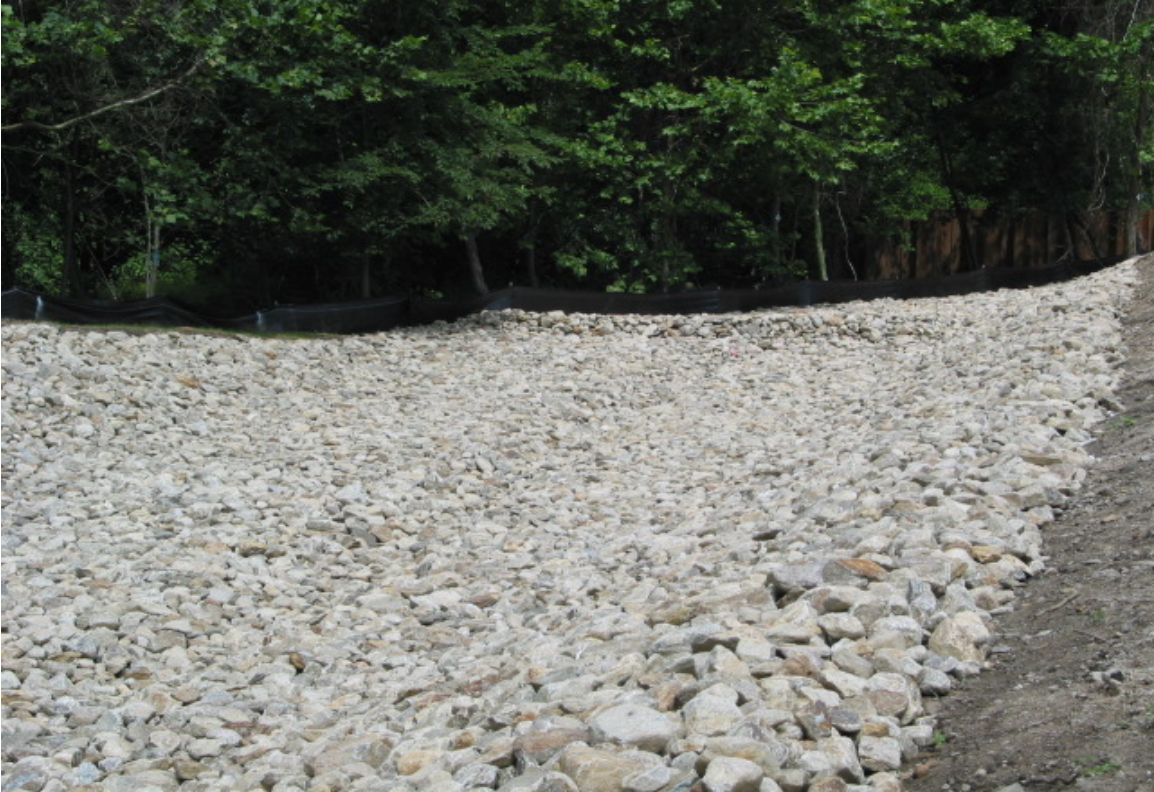
View of the completed portion of the cobblestone installation. The meandering channel and berm will be retained. 7/15/04

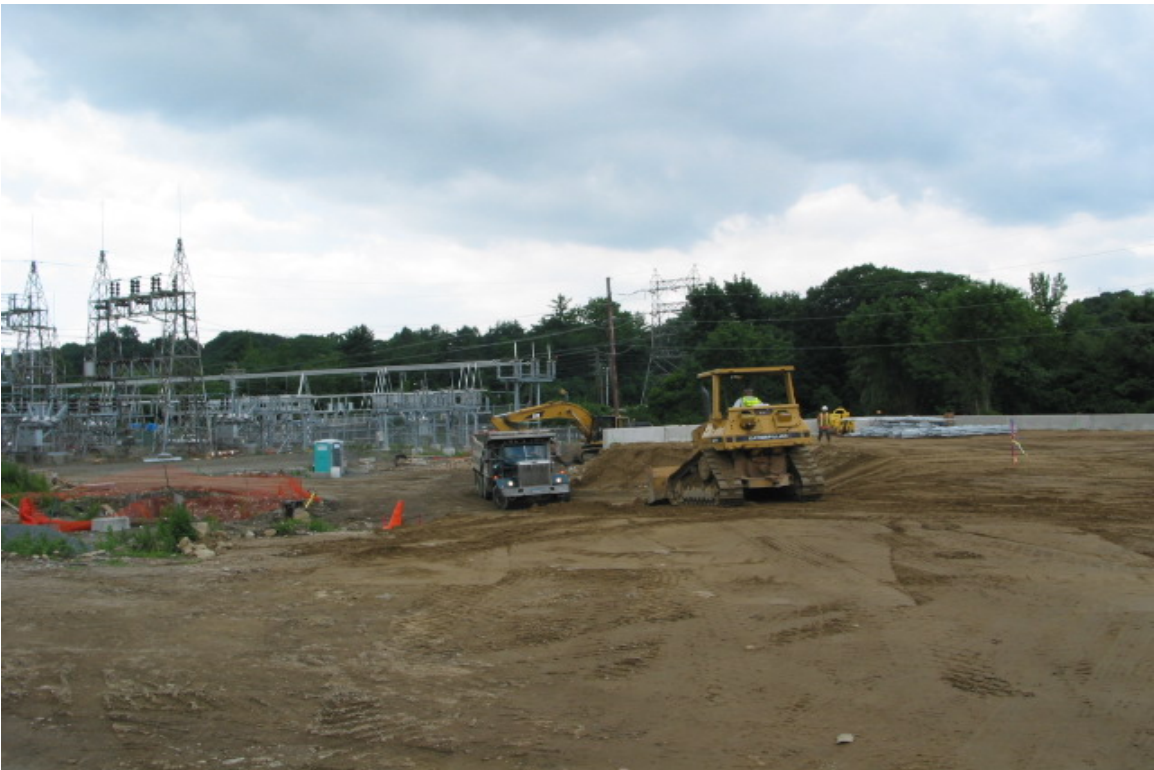
Overall view of the fill operation. A majority of the work here has been completed. 7/15/04

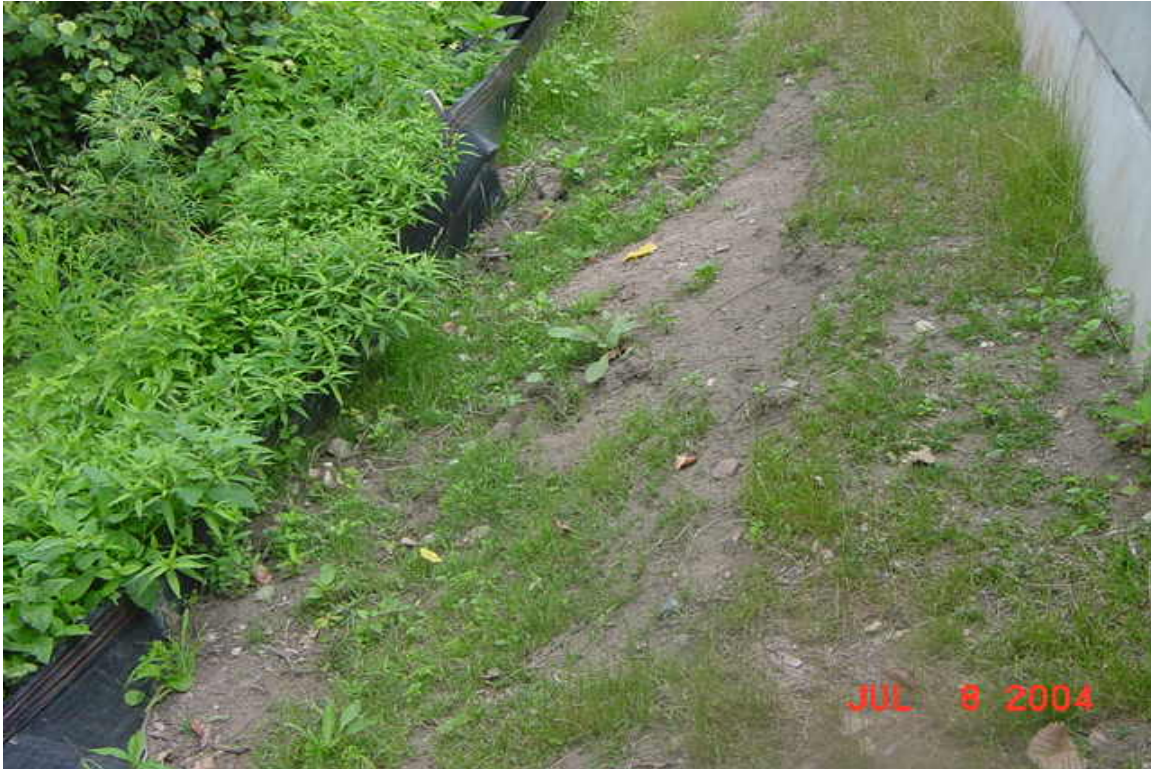
- The area on the slope near the sheet piling cofferdam has some bare soil areas with the potential to get through the silt fence. 7/15/04	- The area should be seeded and stabilized as soon as the cofferdam is removed. 7/15/04
	-Some grass seed was recently placed on the small bare spot in the vegetation below wall #5. Some mulch and watering may be necessary to get growth to occur. 7/15/04	-Continue to monitor for sufficient vegetative growth and future stabilization. This spot could lead to a gully under the right conditions as it is in a fairly steep grade. 7/15/04

View of a sparse area of vegetation below wall #5 taken on 7/08/04 The area has since been seeded and may require some water to establish cover.

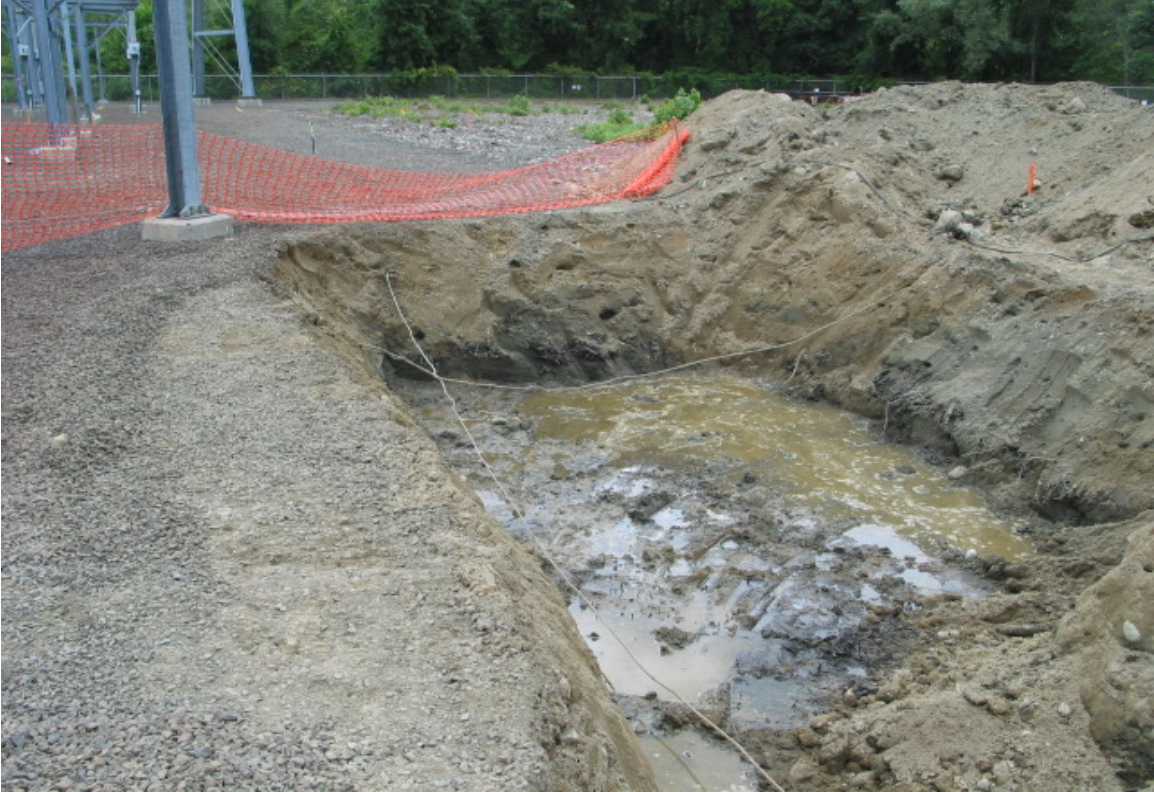
View of the initial excavation area in the Plumtree substation for footings for future structures. The work remains a good distance from the perimeter fence and adjacent wetlands. 7/15/04

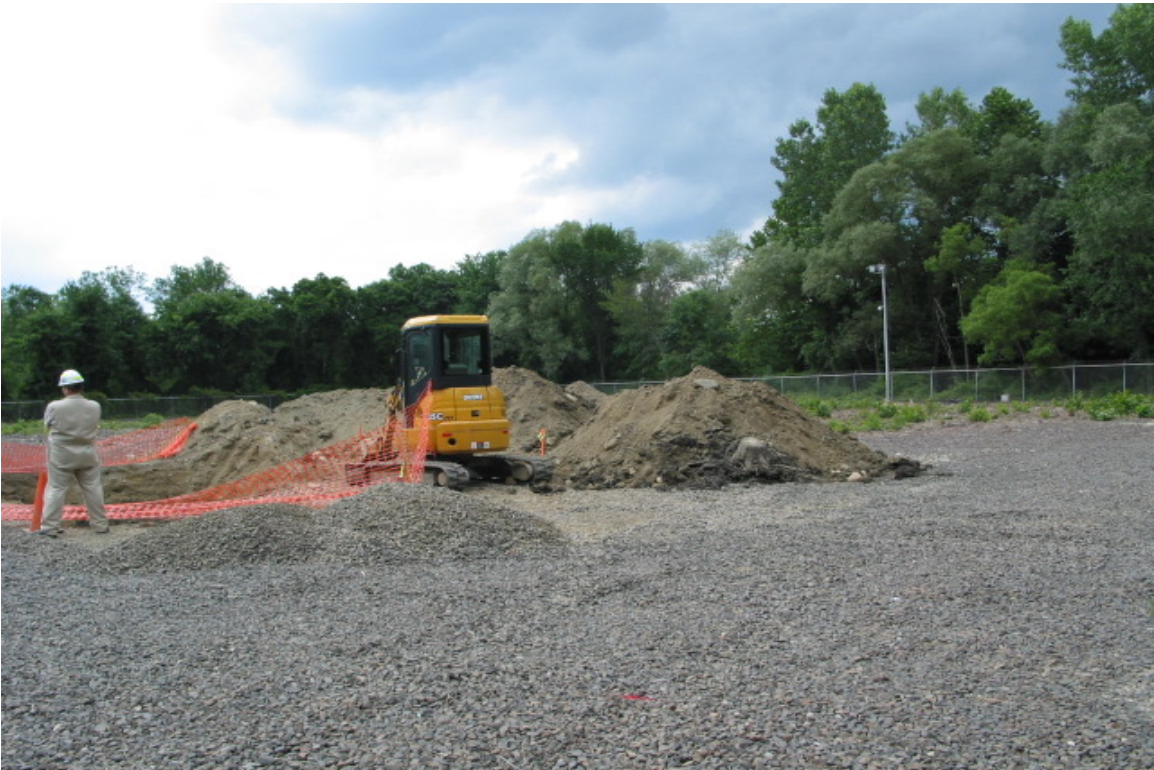
View of the excavation and small stockpile at Plumtree. The area is contained at this time but if stockpiling occurs overnight or close to the perimeter fence, silt fence should be used. 7/15/04
